Spot Safety Project Evaluation

Spot Safety Project # 14-98-021

Spot Safety Project Evaluation of the Actuated Flashing Traffic Signal Installation at the Intersection of SR 1127-(Kanuga Rd-Crab Creek Rd) and SR 1123-Little River Rd in Henderson County.

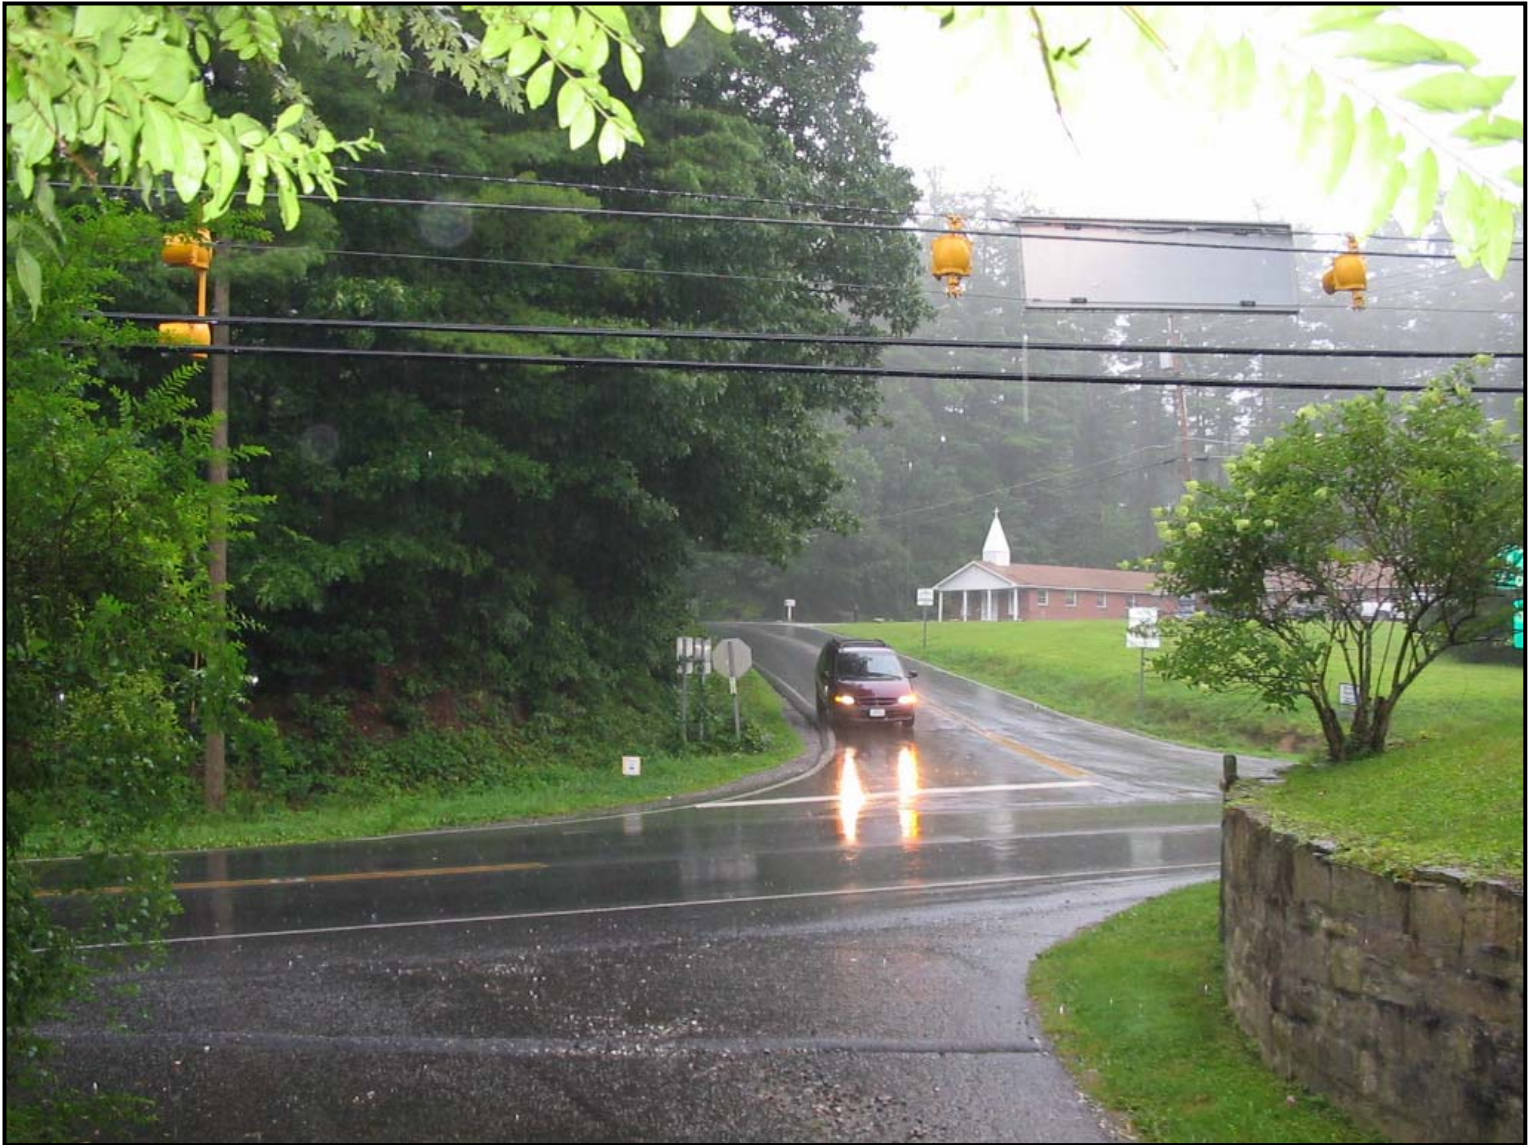
Treatment Site Photos

At the stop sign of SR 1123 – Little River

The crash reduction statistics appear significant from the before to the after period. According to the crash reports and field investigation for the treatment site there is still an existing sight distance issue. The sight distance problem exists for vehicles entering SR 1127 from SR 1123. There are tree branches on SR 1123 that limit the visibility of the over hanging flasher when approaching the treatment intersection (*Please see attached photos*). Improving the visibility of the flasher by trimming the tree branches is recommended. A further investigation into the sight distance issue may also be needed.

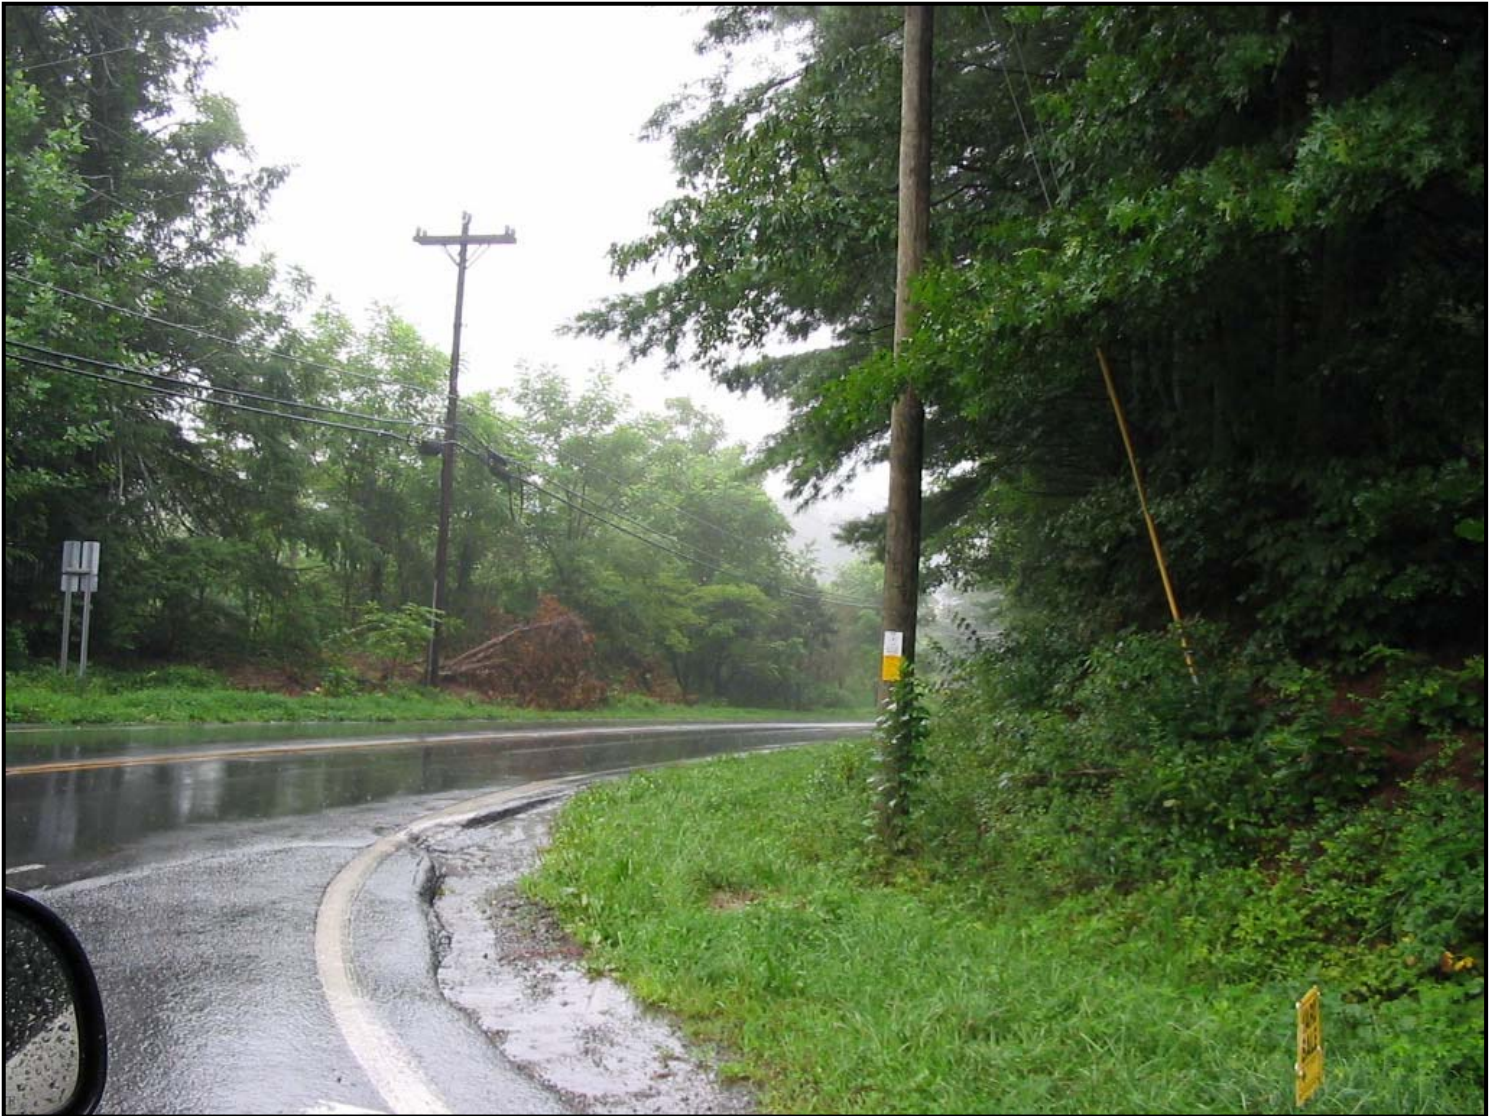
Treatment Site Photos

Sight Distance: SR 1123 – Little River at SR 1127 looking East
